Contract #: 04-0120F4Cty: SF/ALA Rte: 80 PM: 13.2/13.9File #: 1.28**WELDING INSPECTION REPORT****Resident Engineer:** Casey, William**Address:** 333 Burma Road**City:** Oakland, CA 94607**Report No:** WIR-027773**Date Inspected:** 14-Jun-2012**Project Name:** SAS Superstructure**OSM Arrival Time:** 700**Prime Contractor:** American Bridge/Fluor Enterprises, a JV**OSM Departure Time:** 1930**Contractor:** American Bridge/Fluor Enterprises, a JV**Location:** Job site**CWI Name:** As Noted Below**CWI Present:** Yes No**Inspected CWI report:** Yes No N/A**Rod Oven in Use:** Yes No N/A**Electrode to specification:** Yes No N/A**Weld Procedures Followed:** Yes No N/A**Qualified Welders:** Yes No N/A**Verified Joint Fit-up:** Yes No N/A**Approved Drawings:** Yes No N/A**Approved WPS:** Yes No N/A**Delayed / Cancelled:** Yes No N/A**Bridge No:** 34-0006**Component:** OBG/Tower**Summary of Items Observed:**

OBG 13E Deck Drop-in

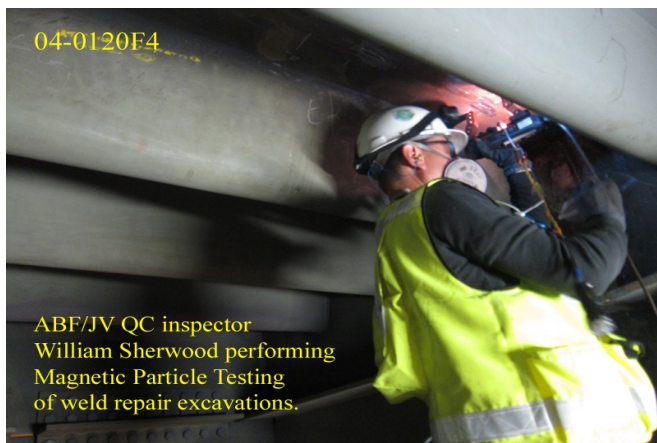
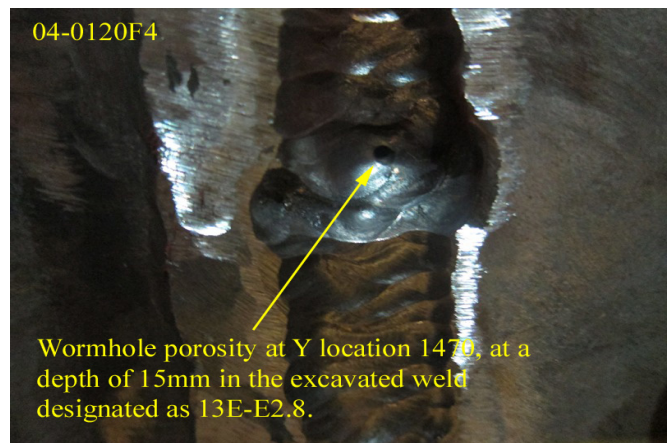
This QA observed ABF/JV QC inspector William Sherwood performing Magnetic Particle Testing and visual confirmation of weld repair excavations that were gouged out the previous shift. The weld is a longitudinal Complete Joint Penetration (CJP) butt joint between the deck and the deck drop-in and is designated as 13E-E2.8. The ABF/JV QC discovered a 3mm diameter pore of wormhole porosity at Y location 1470, at a depth of 15mm in the excavated weld. The ABF/JV QC were aware of the requirements for engineers approval prior to welding at this location due to the achieved depth of the excavation in a fracture critical weld. (See attached photos for details)
